MARINE INVESTIGATION REPORT

M99W0058

STRIKING BOTTOM

**THE BULK CARRIER "CAPE ACACIA"
WEST KINAHAN ISLAND, PRINCE RUPERT HARBOUR
9 APRIL 1999**

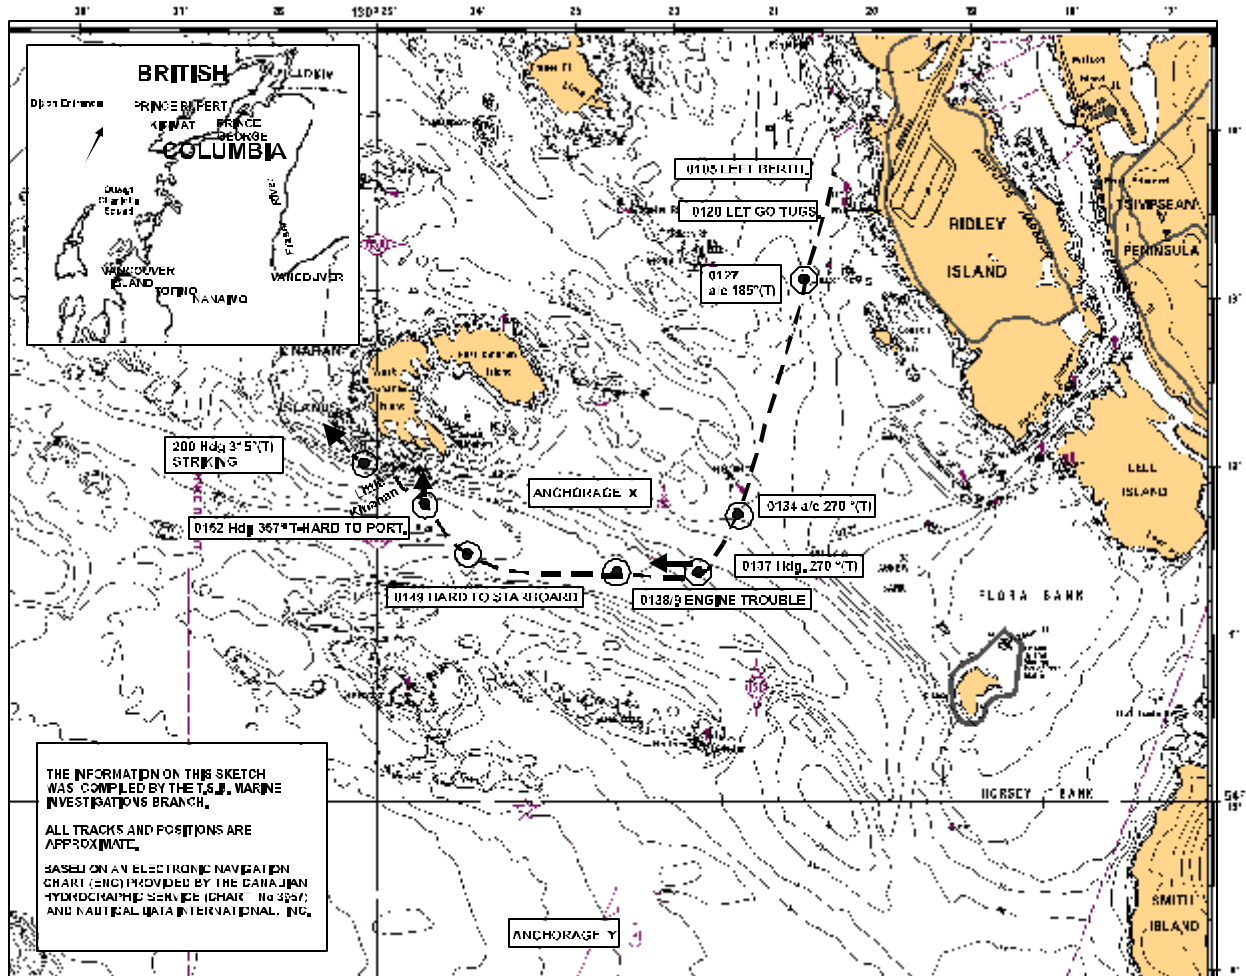
Appendix A - Sketch of the Occurrence Area

5. The "CAPE ACACIA" struck a rocky bottom south of West Kinahan Island, immediately inside the 20 m contour line, during darkness, in fine weather and clear visibility. The starboard underwater section of the bow was badly damaged.
